Article

On the Cleanliness of Different Oral Implant Systems: A Pilot Study

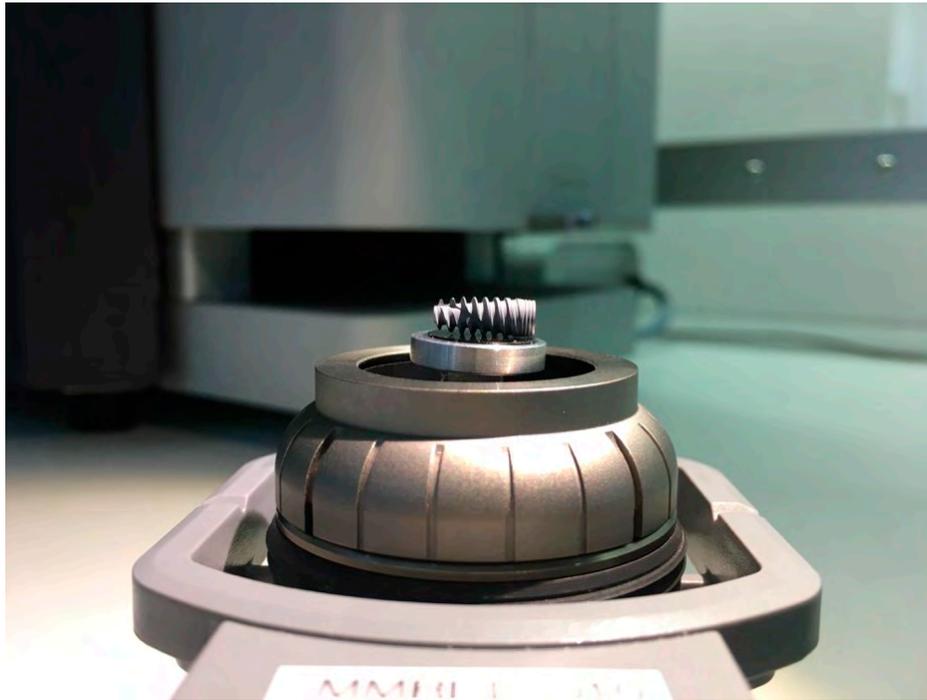
Figure 1. Implant sample with a length of 10 mm mounted on the SEM sample holder.

All of the six samples collected were carefully unpacked, mounted on the sample holder on carbon tabs without touching the implant surface, and analyzed with a scanning electron

microscope (SEM) in a particle-free clean room environment (according Class 100 US Federal Standard 209E, Class 5 DIN EN ISO 14644-1) to avoid artifacts from the ambient air (Figure 1).

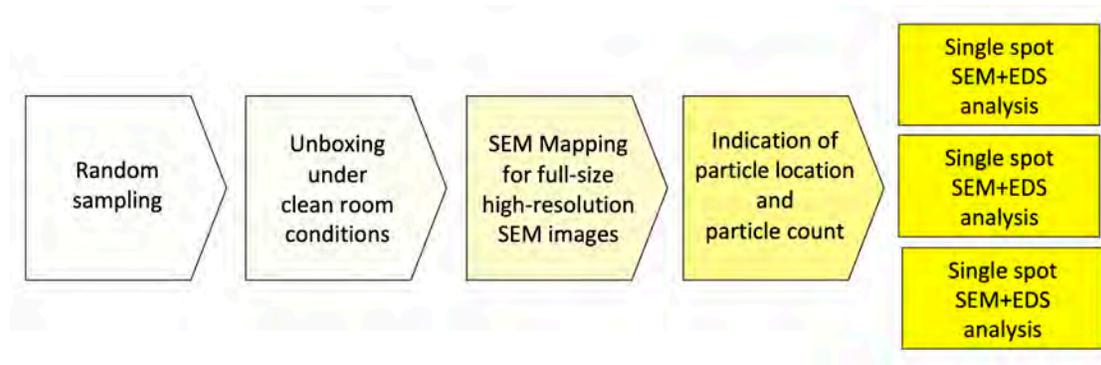
Figure 2. Workflow of the SEM/EDS analysis.

In order to achieve a complete overview of the horizontally mounted implant sample and comprehensive surface quality information in high resolution, implants were scanned at a magnification of 500× in the “Image-Mapping” mode prior to the detailed analysis of potential impurities. This technique produces up to 600 single high-resolution SEM images of the implant surface that were digitally composed into one large image, with an extremely high resolution. The composed SEM image, showing the full size of the implant from shoulder to apex, made it possible to count particles in the visible field (viewing angle of approximately 120°) and to identify areas of interest for a subsequent EDS spot analysis. After the mapping process, SEM images of impurities and other regions of interest were produced with 500×, 1000×, 2500×, and 5000× magnification. In the next step, the elemental composition of particles was determined and, where possible, the differential spectra of particles were achieved to subtract signals from the core material and such focus on signals from the superficial contamination (Figure 2).

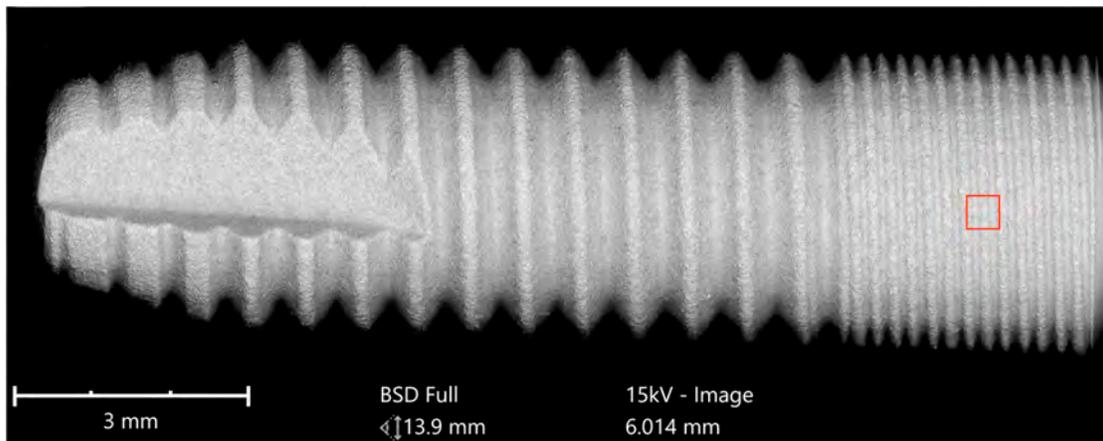
Figure 3. SEM mapping of OsseoSpeed implant (Astra Tech–Dentsply Implants). Magnification of the red marked area is shown in Figure 4.

Implants were analyzed in three groups. In the first group, the implant from Astra Tech–Dentsply Implants (OsseoSpeed) and the implant from Cumdente (AS Implant) were compared. The full-size SEM image of the Astra Tech implant—digitally composed of 455 single SEM images (tiles)—showed a homogenous surface with no foreign material (Figure 3).

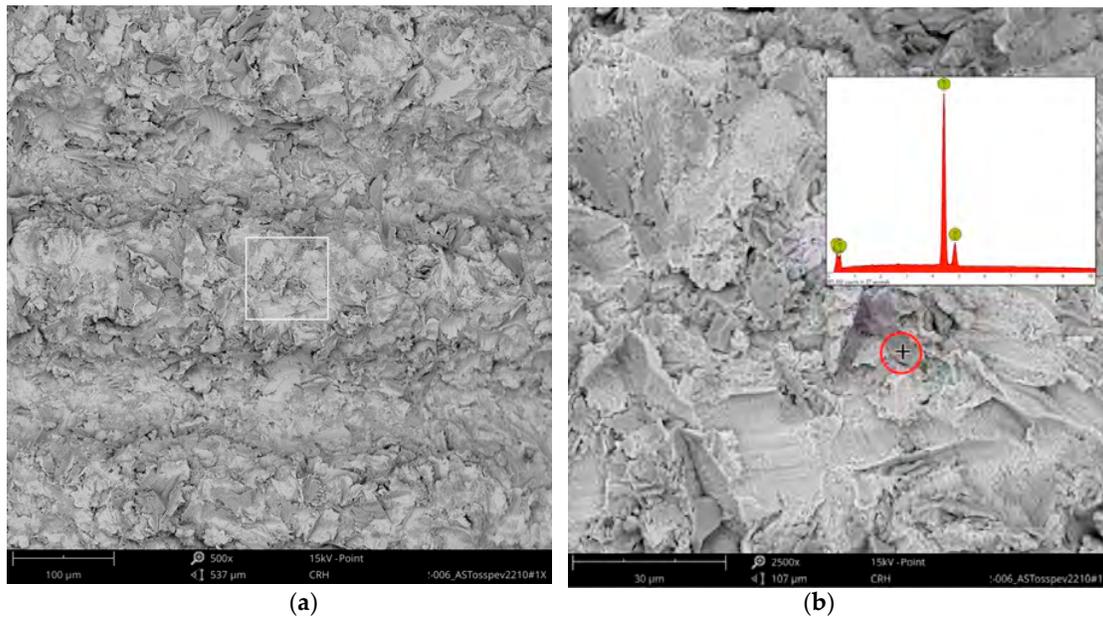
Figure 4. OsseoSpeed surface: (a) the red marked area in Figure 3 magnified 500 \times ; (b) higher magnification (2500 \times) of the white marked area in the left image with EDS spot analysis of an embedded TiO_2 -particle (spot is marked with “+” in the red circle) showing only signals of the blasting material.

Higher magnification could identify the TiO_2 particles from the blasting process seen as sharp-edged particles of 5–10 μm embedded in the titanium surface. Elemental analysis of these particles only displayed signals of titanium and oxygen (Figure 4).

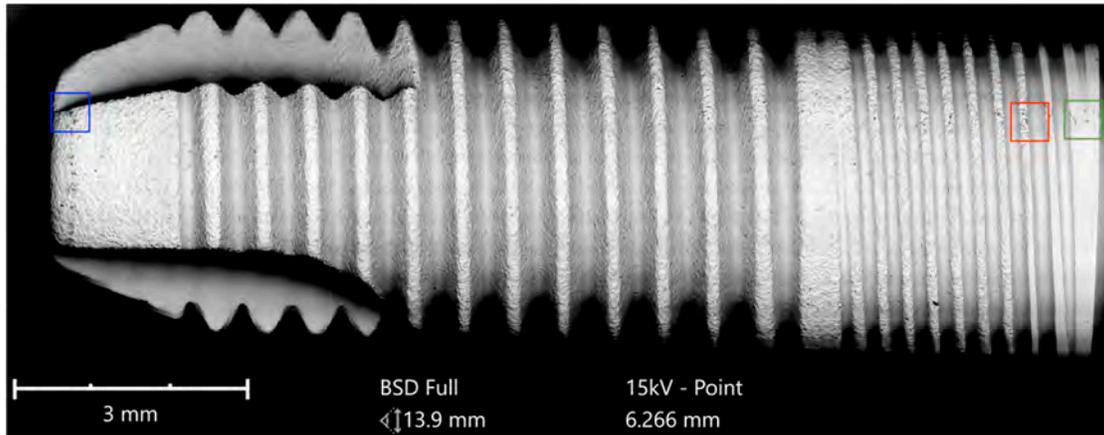
Figure 5. SEM mapping of the AS Implant (Cumdente); Red marked area—see magnification in Figure 6, blue marked area—see magnification in Figure 7, green marked area—see magnification in Figure 8.

The Cumdente implant showed several anomalies in the correspondent full-size image, composed of 422 tiles (Figure 5).

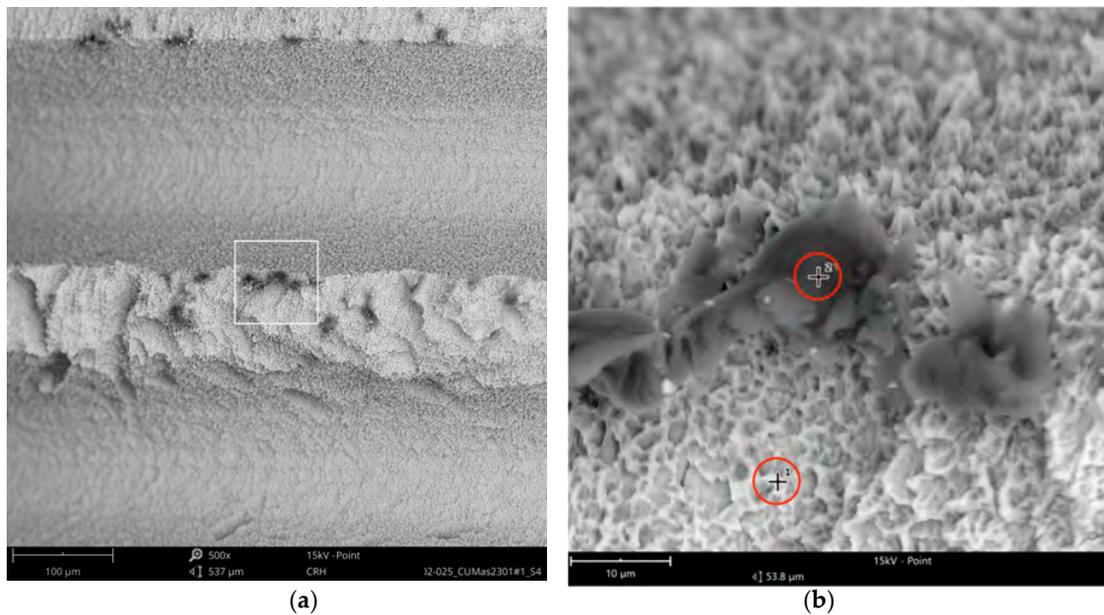
Figure 6. AS Implant (Cumdente) with organic particles (10–50 μm) at the implant shoulder: (a) systematic contamination of exposed threads, red marked area of Figure 5 in 500 \times ; (b) magnification (5000 \times) of white marked area in the left image. The EDS differential measurement of the marked spots was identical to the particles in Figure 7.

The SEM images with higher magnification revealed systematic contamination with multiple (>100) organic particles (5–60 μm) on exposed parts of the implant, as seen on the micro-threads next to the implant shoulder (Figure 6) and near the implant’s apex (Figure 7).

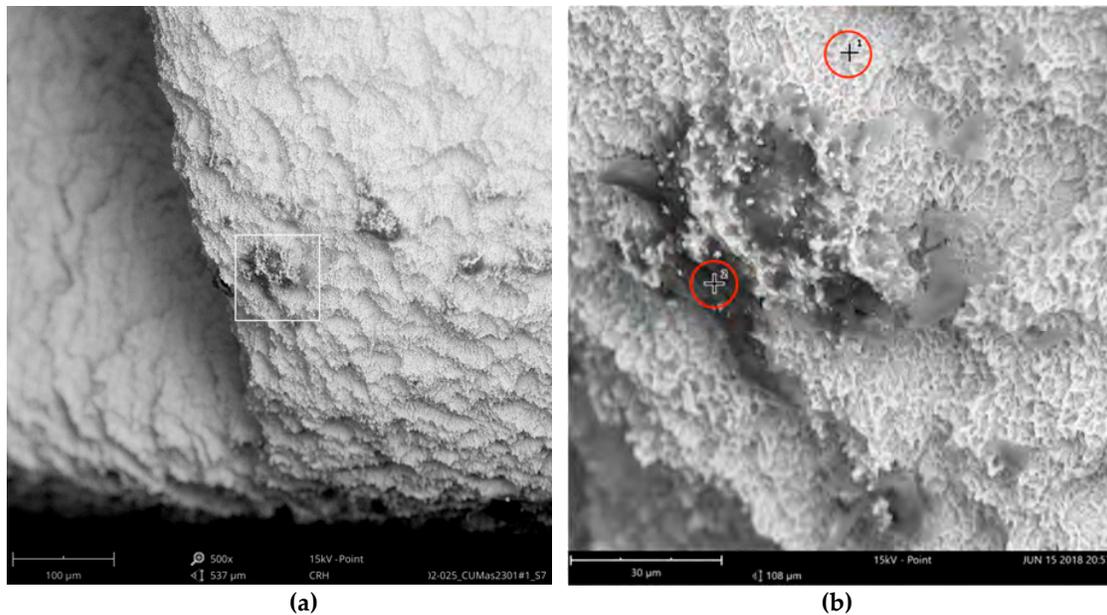
Figure 7. AS Implant (Cumdente) with organic particles (5–70 μm) at the implant’s apex: (a) blue marked area of Figure 5 in 500×; (b) magnification (5000×) of white marked area in Figure 7 (a); EDS differential measurement of marked spots is shown in Figure 8.

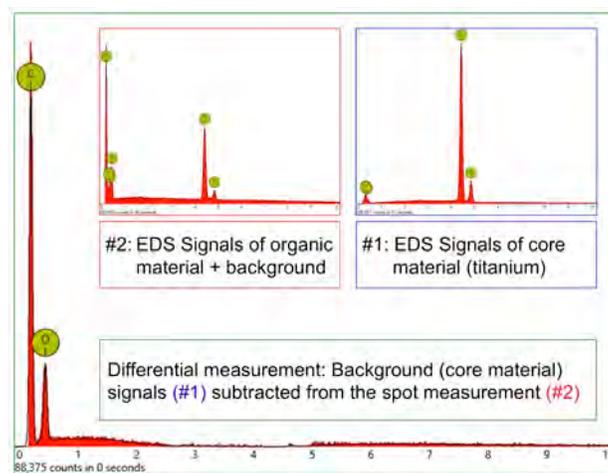
Figure 8. EDS differential measurement of the organic particle in Figure 7. Graph #1 shows titanium as the core material of this implant, with characteristic peaks at 0.452 KeV (La), 4.508 KeV (Lb), and 4.932 KeV (Kb). Graph #2 shows the spectrum of the particle with additional signals of the titanium background. The subtraction of X-ray quanta from the background material reveals the elemental composition of the impurity, which is carbon (characteristic Ka peak at 0.277 KeV) and oxygen (Ka peak at 0.523 KeV).

In order to receive information about the particles’ elemental composition, EDS measurement was performed with a spot focused on the foreign material, where background material was always detected as well, and another spot focused in direct proximity, where only the implant’s core material was detected (spot #1 and #2 in Figures 6b and 7b, respectively). Using a software application, it was possible to subtract the signals of the core material so that the differential measurement revealed more precise information about the elemental composition of the foreign material. Figure 8 shows the differential EDS measurement of the particle in Figure 7, with a clear signal of carbon as the major element in this impurity.

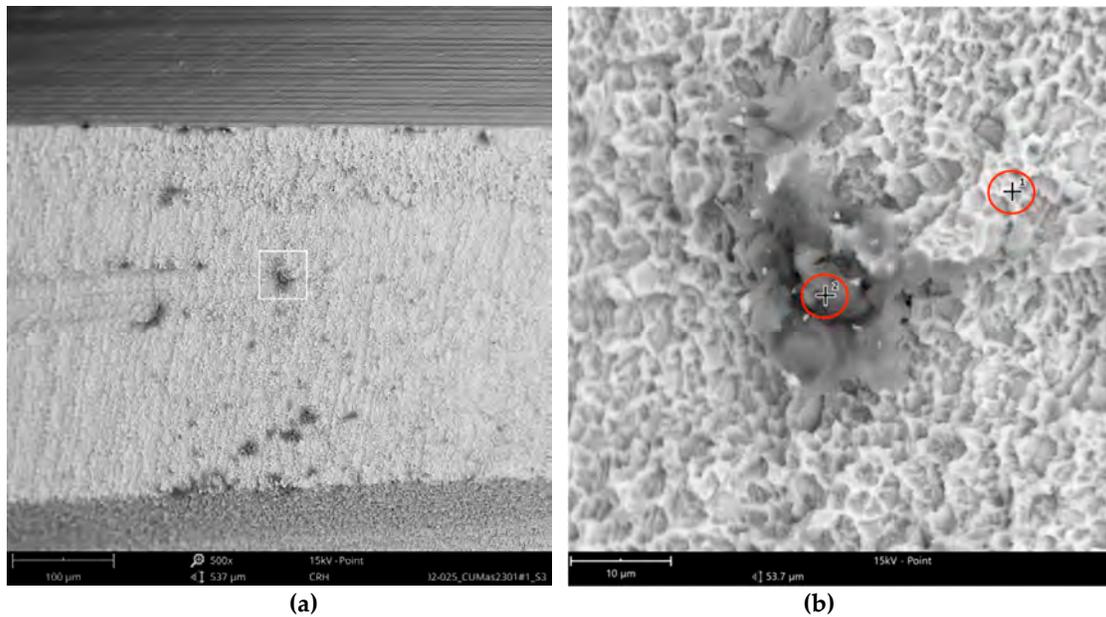
Figure 9. Possible remnants of polytetrafluoroethylene (PTFE), AS Implant (Cumdente); (a) green marked area of Figure 5 in 500 \times shows a larger area of impurities; (b) magnification (5000 \times) of white marked area in the left image; EDS differential measurement of the marked spots is shown in Figure 10.

One larger area at the implant shoulder showed numerous particles (5–40 μm) (Figure 9) with significant signals, not only of carbon but also of fluorine, as seen in the differential EDS analysis (Figure 10). The texture and elemental composition of the foreign material suggest that these particles are most likely remnants of polytetrafluoroethylene (PTFE), used at different implant production stages.

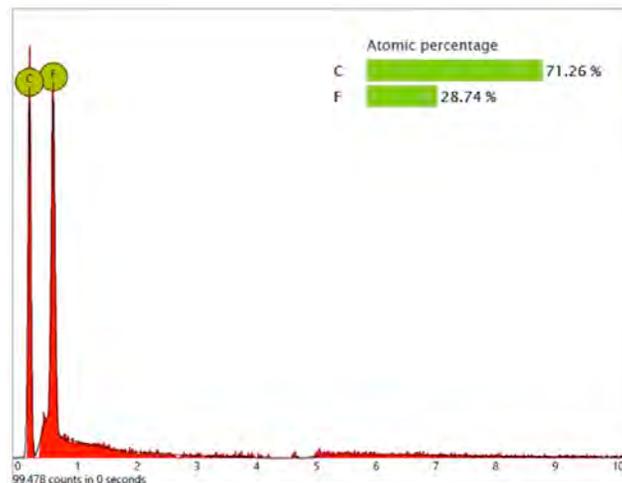
Figure 10. EDS differential measurement of the particles in Figure 9 with significant X-ray quanta of carbon and fluorine. Note that the quantitative information provided by the EDS analysis does not always reflect the precise stoichiometric relationship of the particle's chemical elements.

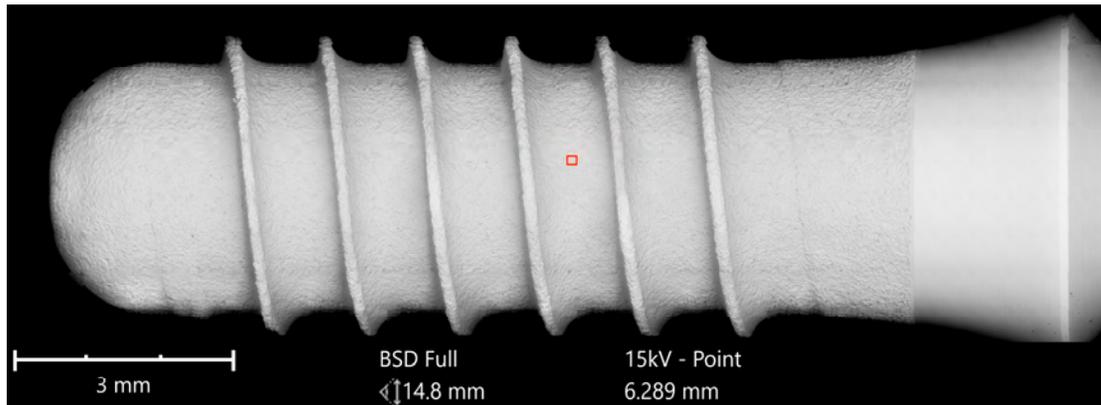
Figure 11. SEM mapping, Standard Plus SLA implant (Straumann); Magnification of red marked area is shown in Figure 12.

ASTM F67 specification. The SEM imaging of the Straumann implant could not detect any organic or inorganic contaminants (Figures 11 and 12).

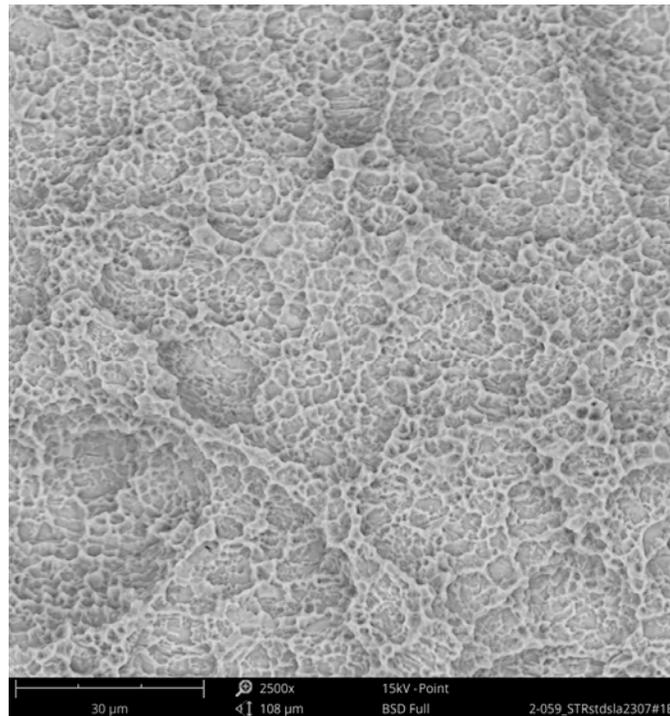
Figure 12. Surface of Standard Plus SLA implant (SEM 2500×); red marked area in Figure 11 with the typical texture of a sandblasted and acid-etched titanium surface, free of foreign materials.

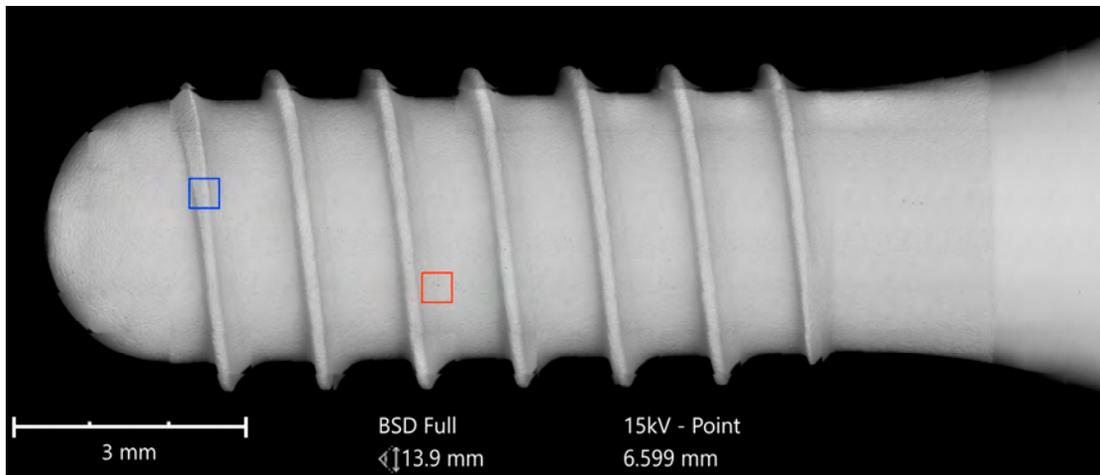
Figure 13. SEM mapping, Tissue Level Implant (Bioconcept); red marked area—see magnification in Figure 14, blue marked area—see magnification in Figure 15.

While the Straumann implant can be rated as clean at the micron level, the analysis of the Bioconcept implant revealed several impurities, although the full-size image showed no systematic larger contamination (Figure 13). With higher magnification, approximately 20 small organic particles (10–20 µm) were found on the implant's surface, one particle showing additional signals of sulfur (Figure 14).

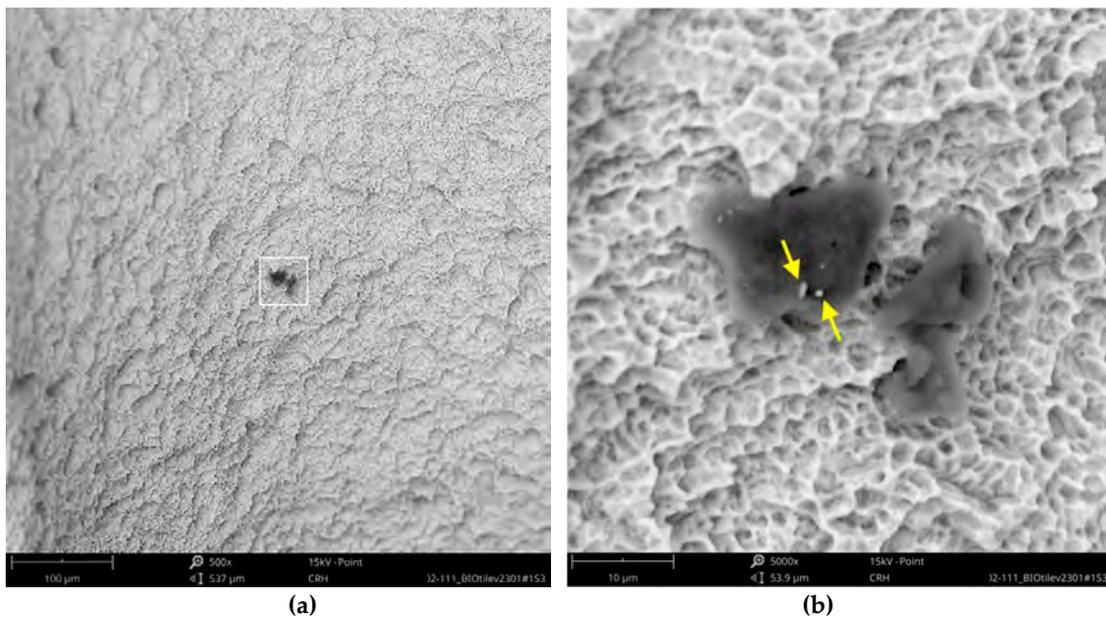
Figure 14. Bioconcept implant with organic particles (10–15 μm); (a) red marked area in Figure 13, SEM 500 \times ; (b) magnification (5000 \times) of white marked area in the left image (a); arrows indicate two embedded metal particles (0.5–1 μm) showing significant iron signals in the subsequent EDS differential measurement.

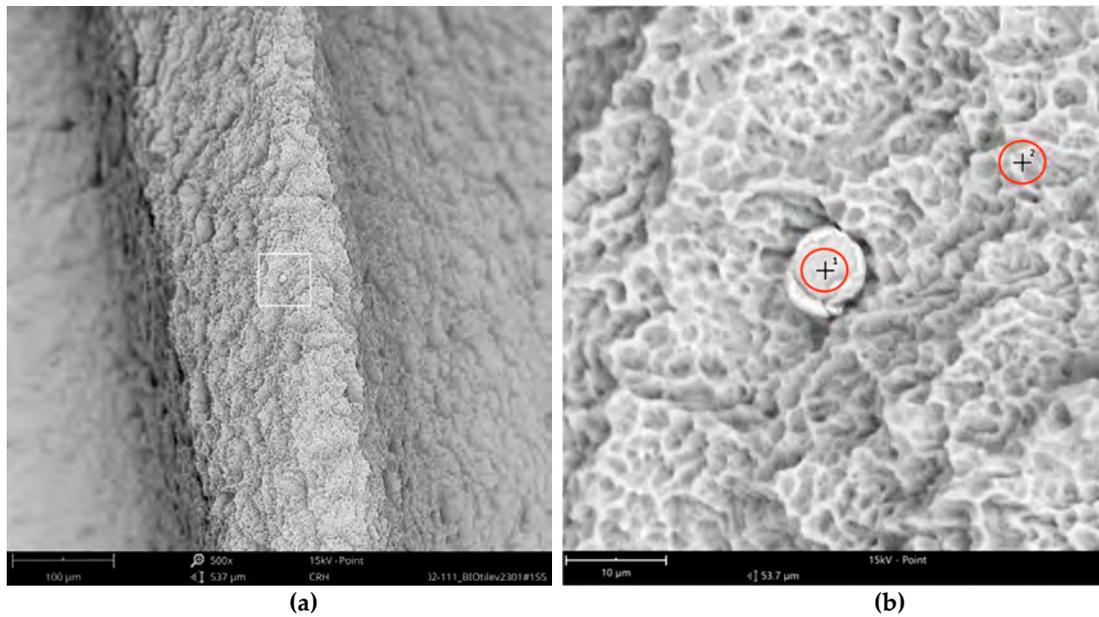
Figure 15. Metal particle on the surface of the Bioconcept implant; (a) blue marked area in Figure 13, SEM 500×; (b) magnification (5000×) of white marked area in the left image (a) showing bright metal impurity (8 μm) and 2 points of EDS spot measurement (#1 = metal particle, #2 = core material).

Surprisingly, one metal particle of 8 μm was found on the Bioconcept implant, seemingly entirely composed of iron, as the qualitative and quantitative elemental analysis and differential measurement of this particle revealed (Figures 15 and 16).

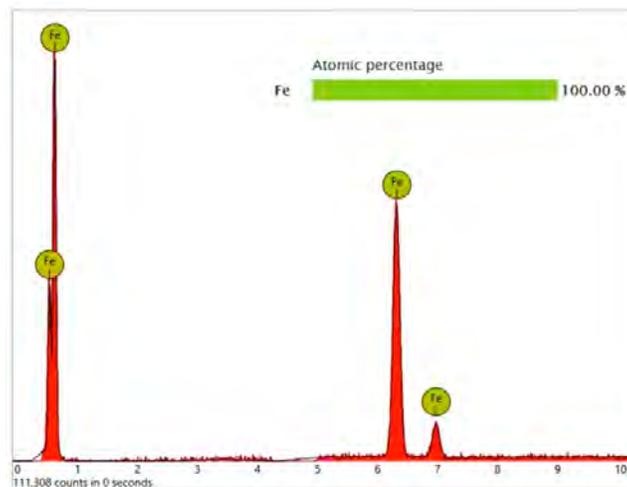
Figure 16. EDS differential measurement of the metal particle in Figure 15, revealing iron as the major element of the impurity.

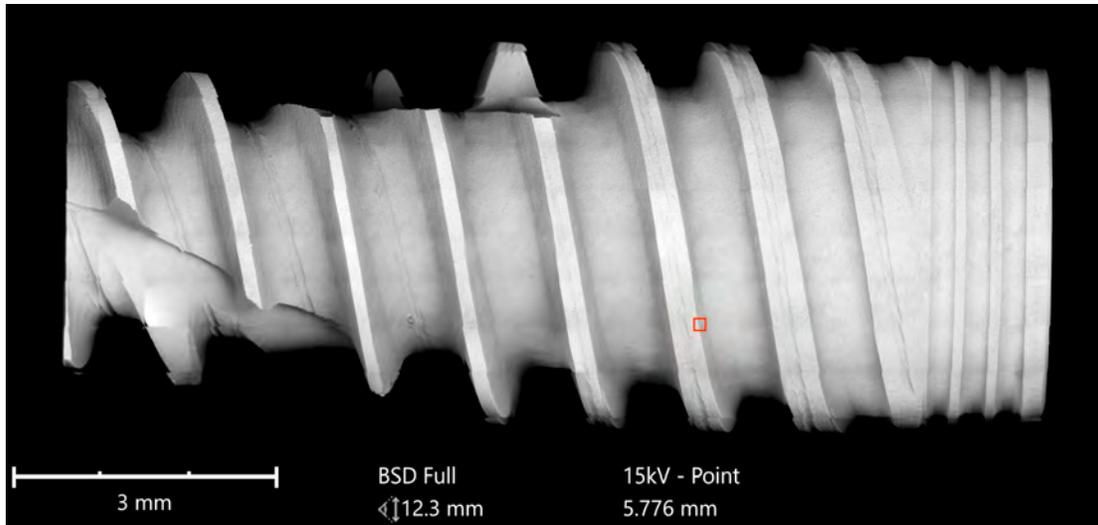
Figure 17. SEM mapping: NobelActive Internal RP implant (Nobel Biocare); red marked area—see magnification in Figure 18.

The third group compared the NobelActive implant from Nobel Biocare with the Dental Implant from Biodenta. Both implants have an anodized surface with a characteristic titanium oxide layer. The area analysis of the NobelActive implant showed calcium and phosphorous signals in addition to titanium and oxygen. Within the scope of this analysis, neither inorganic nor organic particles were detected on the Nobel Biocare implant (Figures 17 and 18).

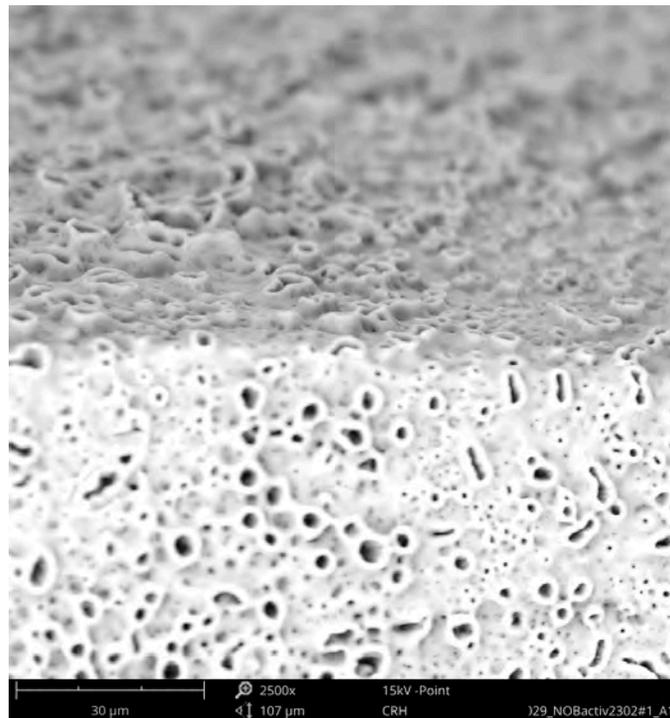
Figure 18. Surface of the NobelActive Internal RP implant (2500×); magnification of red marked area in Figure 17 with the typical texture of an anodized titanium surface, free of foreign materials.

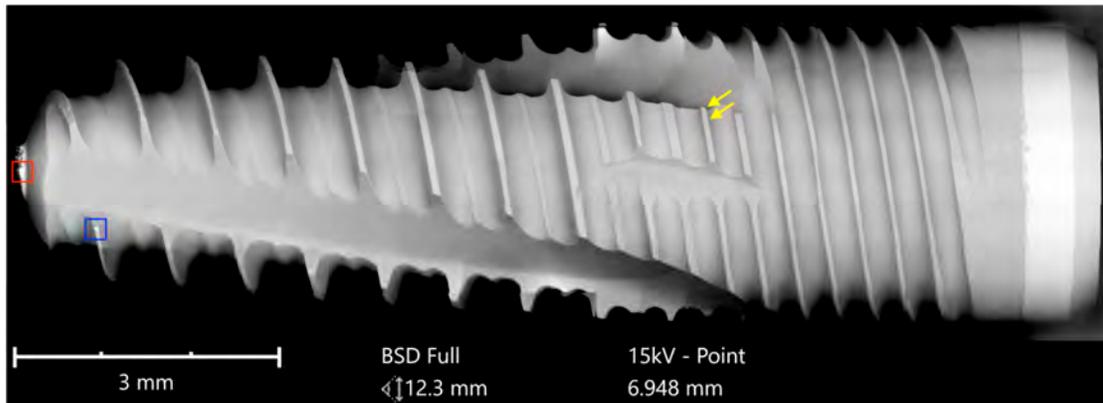
Figure 19. SEM mapping: Dental Implant (Biodenta); yellow arrows indicate spots with aluminum as shown in Figure 21. Magnifications of the blue and red marked areas are shown in Figure 23.

While the full-size SEM image of the Biodenta implant exposed no significant organic contamination (Figure 19), the area analysis of the core material showed, in addition to calcium, phosphorous, titanium, and oxygen, high levels of magnesium in the EDS (Figure 20) that were not seen on the Nobel Biocare implant.

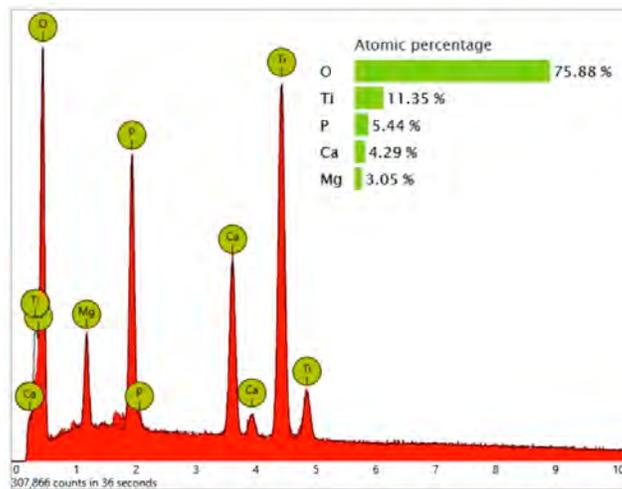
Figure 20. EDS area analysis of the implant’s core material (Biodenta).

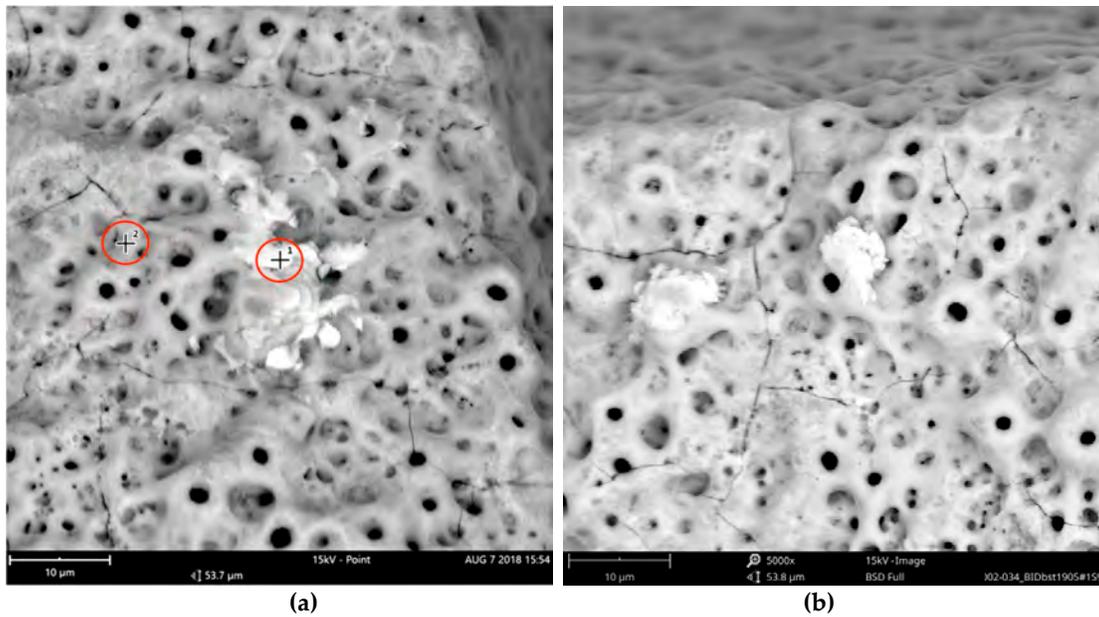
Figure 21. Aluminum-containing particles (5–10 µm) on the surface of the Biodenta implant; location shown using yellow arrows in Figure 19; (a) SEM 5000× with 2 points of EDS spot measurement shown in Figure 22; (b) impurities with similar size in close proximity to particles shown in the left image (a).

Significant traces of aluminum were detected in three areas of exposed threads and can be seen as bright particles (5–10 μm) in Figure 21. The graph in Figure 22 shows the correspondent EDS differential measurement of metal particles in Figure 20a.

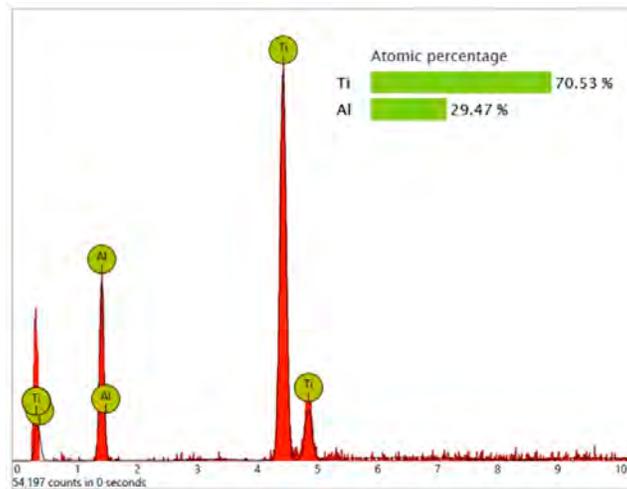
Figure 22. EDS differential measurement of the metal particle in Figure 20 (a), showing significant X-ray quanta of aluminum. The lack of oxygen signals indicates that these particles were not made of aluminum oxide.

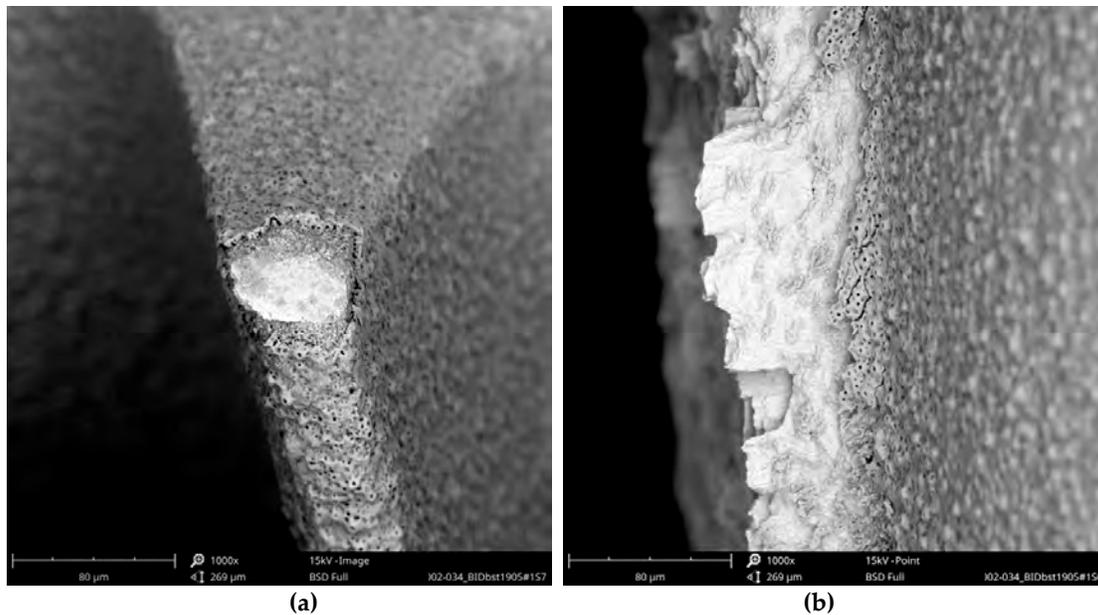
Figure 23. Damaged oxide layer of the Biodenta implant, SEM 1000×: (a) magnification of the blue marked area in Figure 19 showing the damage at the exposed implant thread; (b) magnification of the red marked area in Figure 19 demonstrates the large-area irregularity of the oxide layer at the implant apex.

These aluminum-containing particles must be rated as inorganic impurities as they are not comparable with sharp-edged aluminum oxide particles, used for blasting procedures of other implants. Apart from this, it is noticeable that the approximately 3 µm thick oxide layer was damaged at several exposed locations of the Biodenta implant (Figure 23).
