# Does The Implants Condition At Manufacturing And Packaging Have An Effect On Peri-Implantitis?

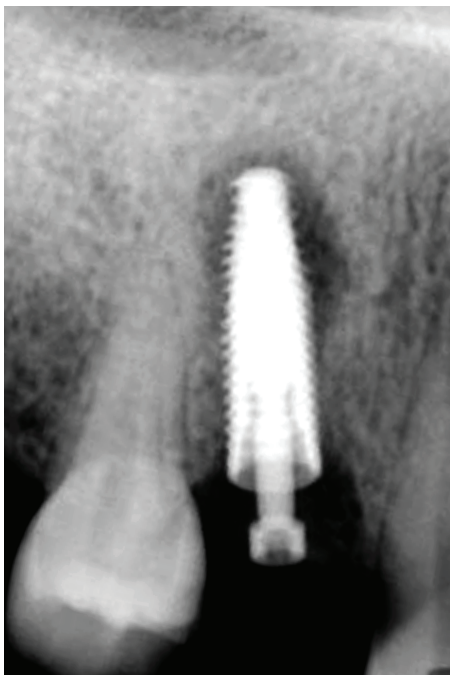
Figure 10: Radiograph of the implant in the posterior maxillary premolar site at 8 months post placement and unloaded demonstrating peri-implantitis at the apical half of the implant with no noted bone loss at the crestal half of the implant.

Figure 11: Radiograph of the implant in the posterior left maxillary premolar site at 8 months post placement and unloaded demonstrating peri-implantitis at the apical half of the implant with no noted bone loss at the crestal half of the implant.

The exposure of implant threads to the oral environment with subsequent bacterial colonization is often described as the “beginning of a bad ending”. One might expect to see mainly bone loss in the crestal area and translucencies in the corresponding radiographs. However, significant carbonaceous contaminants at the apical region of implants may well lead to bone resorption that look in radiographs like a periapical lesion of an implant. (Figures 10 and 11))

At 8 weeks post implant placement the patient returned to monitor the progress of soft and hard tissue healing. A periapical radiograph was utilized to evaluate any changes in the implant's appearance in relationship to the surrounding bone. The radiograph's for both implants revealed a radiolucent "halo" at the apical 1/3 – 1/2 of the implant while the coronal aspect of the bone remained stable. (Figures 10 and 11) The patient was informed about the unusual clinical presentation and was prescribed Amoxicillin to reduce the bacterial count although there was no exudate or fistula present. The proposed intervention procedures were reviewed with the patient. Two potential etiologies were discussed: (1) the implants may be failing; and (2) there may be a specific issue occurring only at the apex of each implant. The patient was then re-scheduled for a surgical intervention the following week while the antibiotics were present in her system. The healing collars were removed and objective ISQ measurements were recorded for both maxillary implants and both registered a stable 75 - 77. Based on the stable ISQ values, it was determined that both implants were integrated enough for loading, but due to the radiolucent presentation it was explained to the patient that a surgical flap procedure could be accomplished to assess

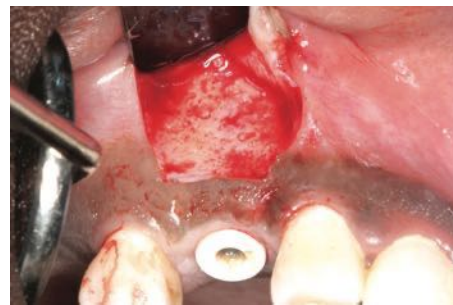
Figure 12: Clinical appearance of the buccal plate overlaying the implant in the upper left maxillary premolar area following elevation of a full thickness flap.

The surgical intervention was similar for both right and left implant receptor sites. Local infiltration with 2% Lidocaine with 1:100,000 epinephrine in the vestibule over the implant sites. Right and left semi-lunar full thickness flaps approximately 5 mm below the gingival crest revealed intact buccal plates without apparent fenestration. (Figure 12) The buccal plate was carefully removed utilizing Piezosurgery (Mectron Columbus, Ohio) exposing the apical portion of each implant. (Figure 13) The SmartPeg (silver post) secured to the implant recorded the ISQ values demonstrating a value of 77 indicating stability of the implant and repair of the apical defect could be performed versus explantation. (Figure 14) The thickness of the buccal cortical plate can be visualized in Figures 16 and 17. The areas were then mechanically debrided, rinsed with chlorhexidine gluconate 0.12% followed by thorough flushing with sterile saline. 0.5 cc's of mineralized cortico-cancellous bone (Maxxus Kettering, OH) was packed within each defect and then covered with dehydrated human deepithelialized amnion-chorion

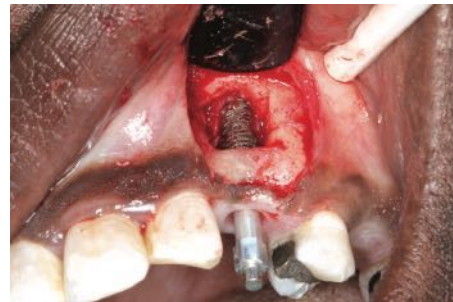
Figure 13: The buccal plate was carefully removed utilizing Piezosurgery exposing the apical portion of each implant.

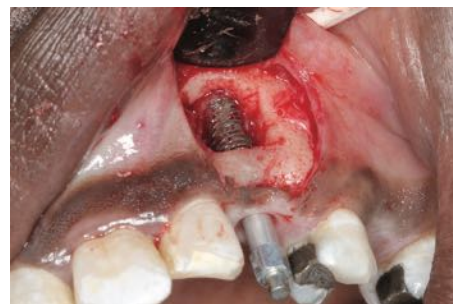
Figure 14: ISQ was tested with a SmartPeg demonstrating a value of 77 indicating implant stability despite the apical defect, so osseous repair could be performed versus explantation.
