**The CleanImplant® Trusted Quality Mark**

Process Description and Performance Criteria

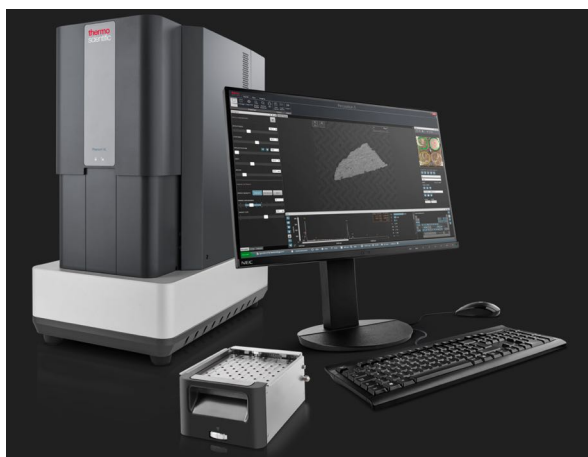
The scientific workstation features a Phenom Scanning Electron Microscope, equipped with a high-sensitivity backscattered electron detector, which enables both compositional and topographical imaging modes. Energy Dispersive X-ray Spectroscopy (EDS) analysis is performed with a thermoelectrically cooled Silicon Drift Detector (SDD).

Workstation with Phenom Scanning Electron Microscope

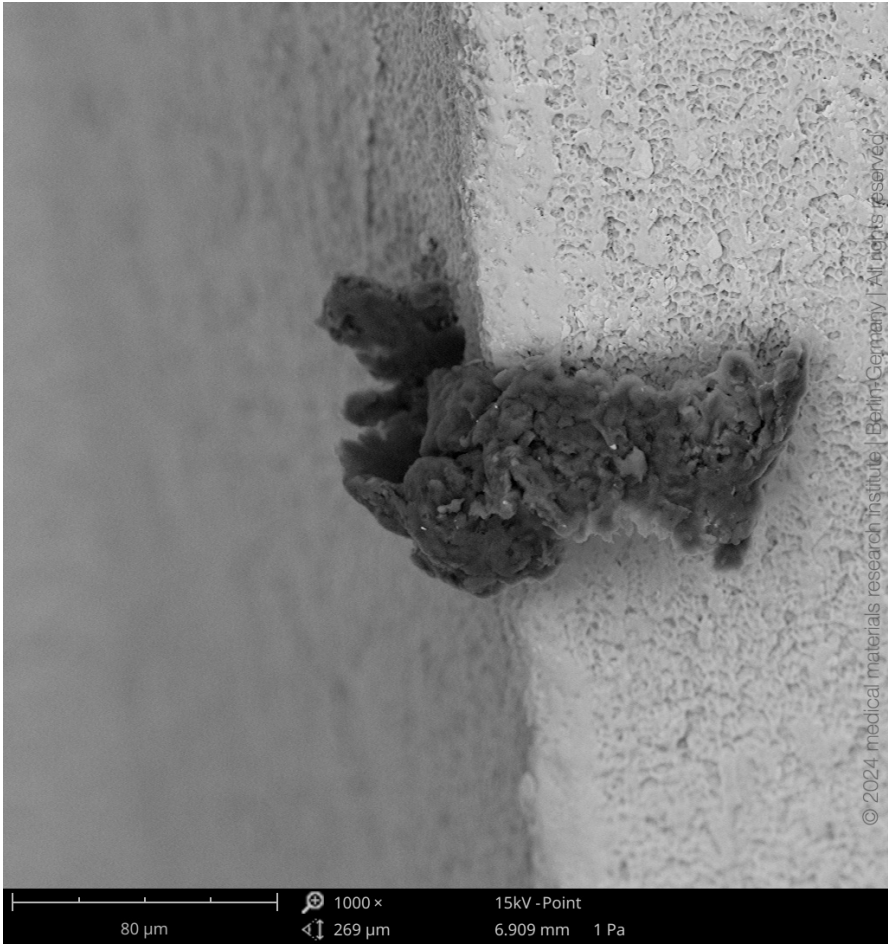
Large contiguous organic particles (50-600 µm)

(Different implant systems)
